Urban flash flood in Gdańsk – 2001. Case study

Wojciech Majewski

Keywords: Gdańsk, urban flash flood, Radunia Channel, Gdańsk Water Node, engineering proposals

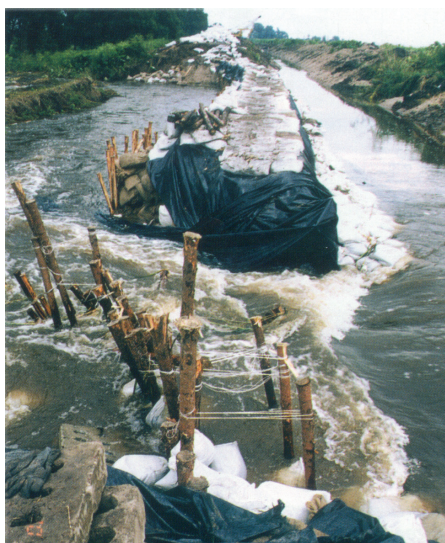
Fig. 6. Breached embankment of the Kłodawa River (Majewski 2010)

- The embankment of the RCh was breached in 5 places, which resulted in flooding of the part of the city situated on the right side of the channel and the main road (Fig. 3);
- Two main roads approaching Gdańsk from the west became torrential rivers. One of them is shown in Fig. 4;
- Gdańsk main railway station was flooded, which caused one week's stoppage in rail traffic (Fig. 5);
- The head dam of the reservoir on the Strzyża Stream in Gdańsk was breached, which resulted in a severe flood along the main street and flooding of the crossing of the main road between Gdańsk and Gdynia;
- One day later (10th July), the left side dyke of the Kłodawa River, situated about 10 km south of the RCh, was breached, which resulted in the inundation of a large agricultural land (Fig. 6).

The breaching of the right-hand dike of the Kłodawa River caused a very dangerous situation, because the water level in the river was much higher than in the surrounding terrain. Therefore, the repair of the gap in the flood dyke

was urgent. Access to this place was unfortunately only over the narrow crest of the dyke. It took 2 days to complete the task and a large volume of water discharged from the river and inundated agricultural terrain.

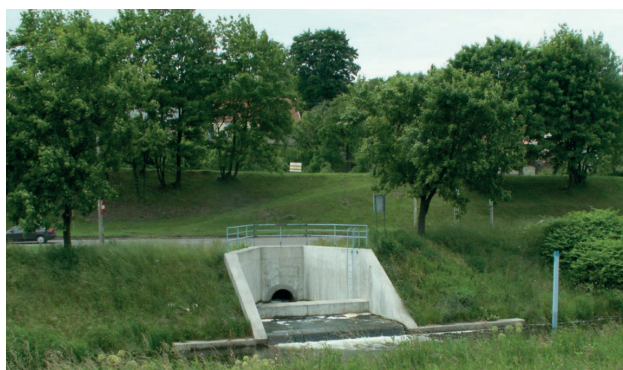
Fig. 14. New outlet from the RCh to Radunia River. In the background is the road to Gdańsk and the embankment of Radunia Channel. Maximum discharge through this outlet is $13.0 \text{ m}^3/\text{s}$ (Majewski 2010)

and a new outlet from the RCh to the Radunia River is presented in Fig. 14. One of the retention reservoirs is shown in Fig. 15, and a modified outlet of one of the streams into the RCh is shown in Fig. 16.
