Protection of settlements from floods and debris flow on the example of tragedy in Tbilisi on 13-14 June of 2015

Abstract. This article presents material about the flood on the Vere River on 13-14 June, 2015. It caused significant economic and ecological damage to the country, and there were also human victims. The reasons for the ecological disaster are evaluated and appropriate hydrological calculations have been carried out. It has been particularly established that the predictable (forecasting) maximal discharges of 0,1% value for Vere River is 520 m³/sec and not 410 m³/sec, that was calculated water conduct tunnels in the entrance of city before the Mtkvari River.

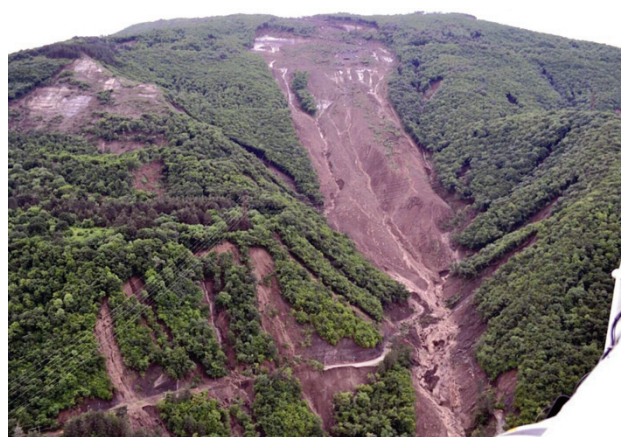
Fig. 2. General view of a landslide formed on the vulnerable slope of the Jokhoniskkhevi River, right tributary of the Vere River (photography by Robert Diakonidze)

the formation of a landslide on the vulnerable slope of the Jokhoniskhevi River, temporary outlets of infiltrated water present on the slope surface are clearly visible (see Fig. 2).

In our opinion, one of the reasons for the landslide development in the Akhaldabiskhevi and Jokhaniskhevi Rivers (there are many potential landslide centers in the region), in addition to many other factors, is the motorway, clearly a manmade structure. The mass of landslide and debris flow amounted to approximately 1 million m^3 .

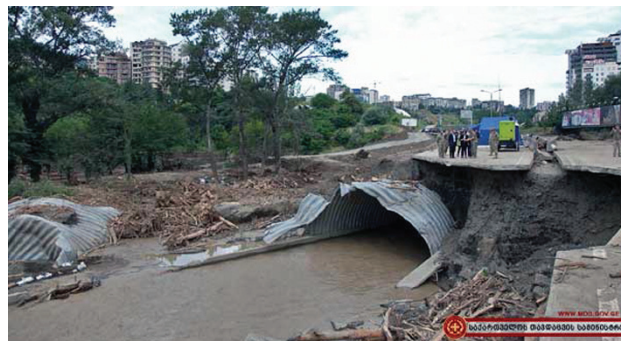
Fig. 4. Newly built tunnel broken by water flow (photography by Robert Diakonidze)

- In urban settlements it is inappropriate to build a closed type of water permeable construction (in this case – tunnels); if it is necessary to build such constructions due to specific geographical conditions, the strict requirements of first class construction should be considered.

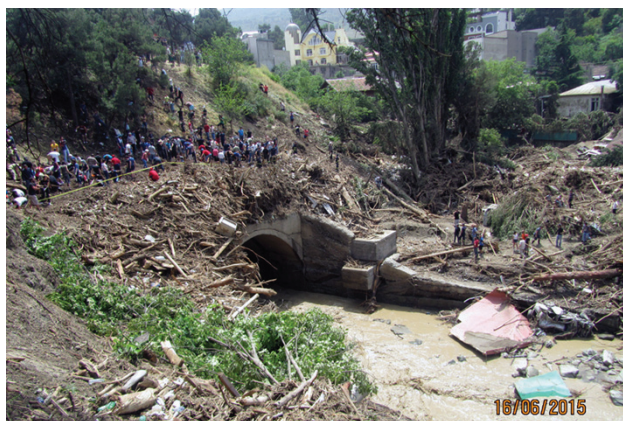
Fig. 3. Oval tunnel positioned under the Vake-Saburtalo motorway and the place of flooding (photography by Robert Diakonidze)

It is already known that the Vere River, after flooding in Tbilisi territory, first rushed through the bridge-tunnel (length 126 m) that connects two neighbouring districts (Vake and Saburtalo), and then, before joining the Mtkvari River, it flew into a closed water tunnel. The distance from the confluence to the first bridge-tunnel is 4,8 km. The water permeability of the first bridge-tunnel, according to materials in the project framework, is intended for 460 m^3/sec water transfer, and the closed tunnel located after the above tunnels is intended for 410 m^3/sec (Kereselidze et al. 2015).

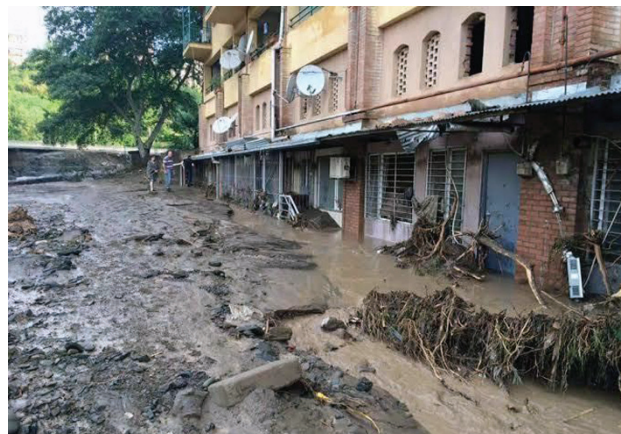
Fig. 5. Flooded settlement territory as a result of broken newly built tunnel (photography by Robert Diakonidze)

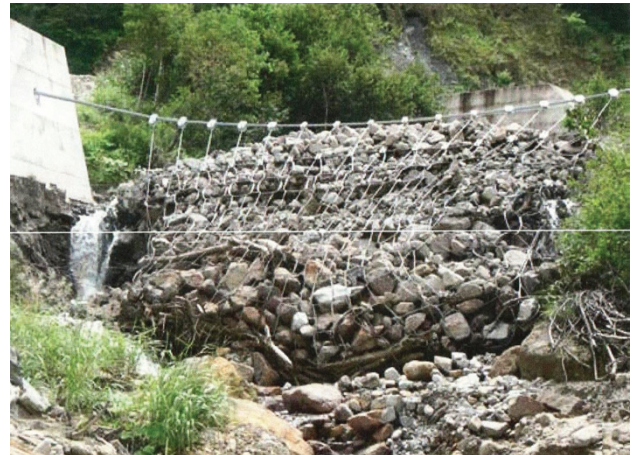
- To avoiding such tragedies as occurred in Tbilisi and to protect similar geographical environments from floods and mud flow we recommend installing a lattice-like structure to serve as a sediment trap; the first prototype of this was developed in the Georgian Scientific Research Institute of Hydraulic Engineering and Reclamation (now the Tsotne Mirtskhulava Water Management Institute of the Georgian Technical University), and has been developed into its modern version by the Swiss firm Geobrug (Fig. 6).

Fig. 6. Construction of lattice type metal networked sediment trap

The proposed premise has many positive aspects: it will save resources, offer high performance and multiple operational ability.
